LOST CREEK DAM

MCKEESPORT Y.M.C.A.

PHASE I INSPECTION REPORT
NATIONAL DAM INSPECTION PROGRAM

PHASE 1 REPORT
NATIONAL DAM INSPECTION PROGRAM
LOST CREEK DAM
NDI ID. NO. PA 739

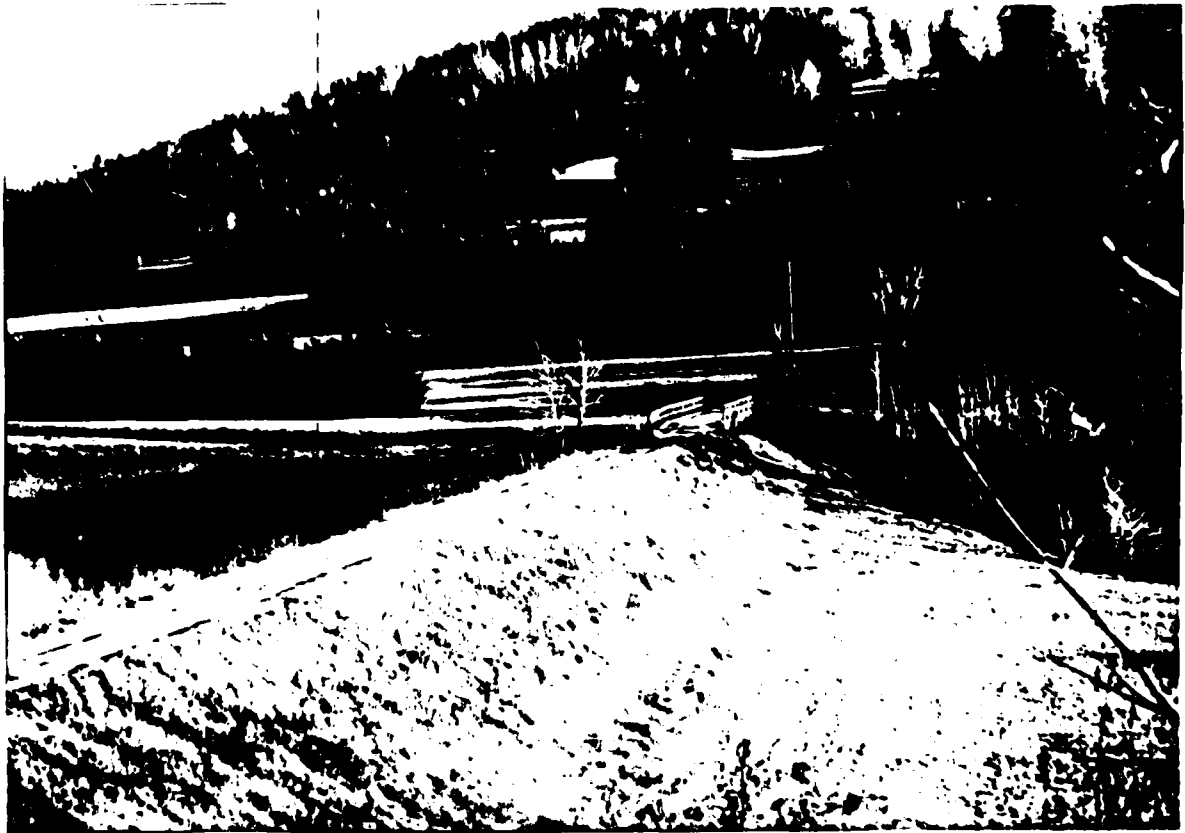
OVERVIEW OF DAM
